81-85 12A Shutter Valve (Coasting Valve)

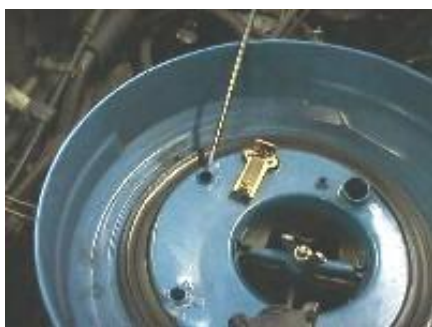
TESTING: With the engine running at an idle, there should be NO air being sucked through the air filter hole as shown in the picture. Just put your finger over the hole to see if there is any vacuum. If it is pulling air the valve is probably no good.

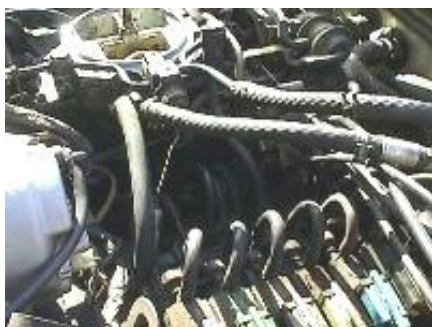
The valve you are heading for is buried down in this mess!

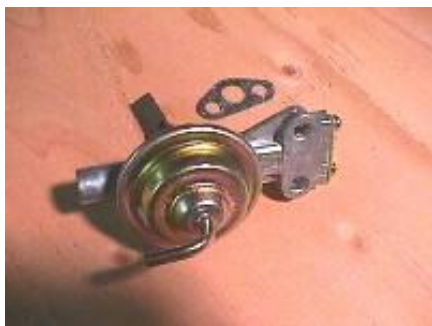
The new valve looks like this. The images below show where it bolts onto the manifold. On the lower right image, note how the linkage of the valve hooks onto the manifold butterfly shaft. This linkage can also break, which means you had to do the valve anyway. Note: When you get to where you can see the end of the butterfly shaft, check the wear on the pin that the valve linkage slips over - if it is worn too much (or sometimes even broken off), then you need to replace the intake

manifold (with a better used one) or replace the butterfly shaft.

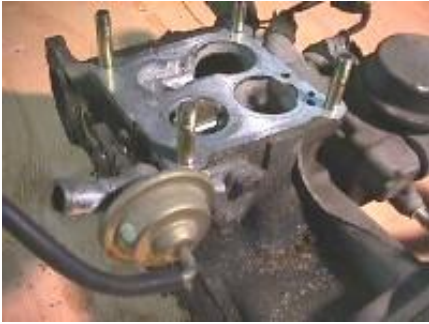
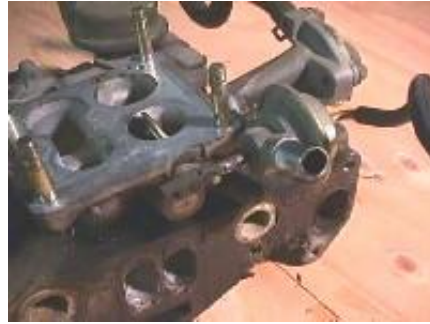
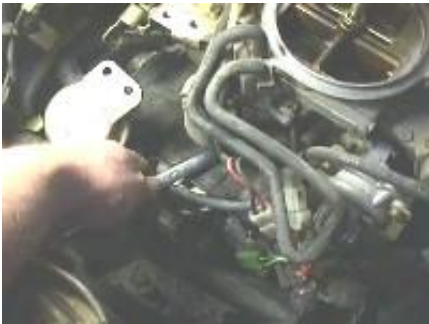
The two carb base nuts on the fender side are removed with a normal 12mm wrench. Note the afterburn valve has been unbolted from the carb.

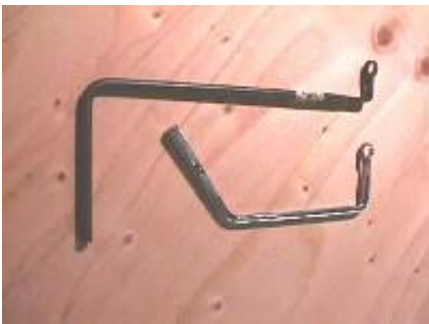
These two 12mm wrenches, or ones very similar, are by far the best way to get to the two engine side carb base nuts. We have not found any easy way to get to those two nuts without these - sorry.

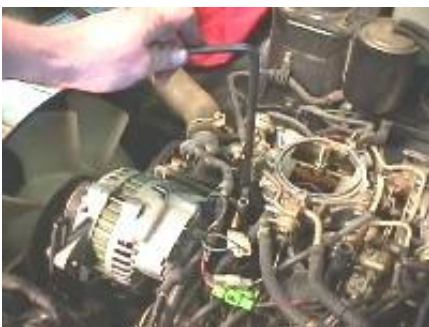
The wrench with the shorter base length is used on the forward nut, and the one with the longer base on the rear nut.

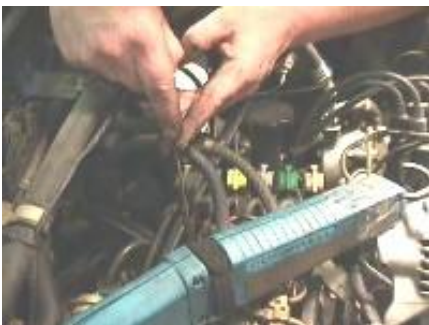
Here we are fishing out the dropped nuts with a long magnet - you will do this a lot. The magnet is also used to re-install the nuts, so be sure you have one.

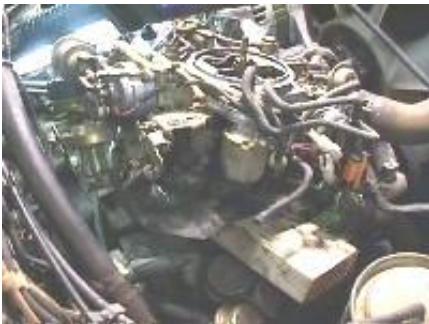
When the four carb base nuts are off (and retrieved with the magnet), and the afterburn valve is unbolted from the carb, the carb can be lifted up and held with a short 2x4 under it.

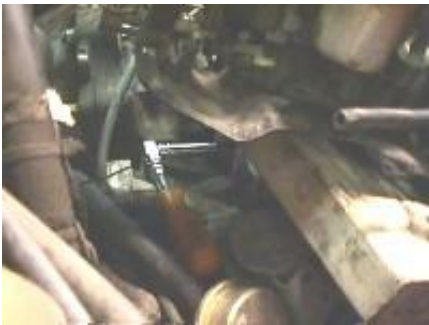
The two bolts holding the valve to the manifold are now accessible. We prefer using a 1/4" ratchet with a deep 10mm socket because there is limited room. If the gasket is in VERY good shape, you can risk not replacing it, otherwise scrape it off. If replacing it, then glue the new gasket to the valve with Gasacinch, or something similar.

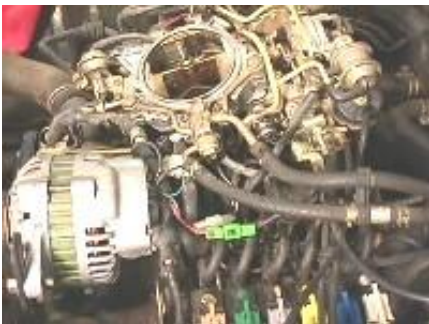
This is a view from the other side, with the carb held up by the 2x4. Note that none of the vacuum hoses needed to be removed. Caution: be careful with the oil metering pump lines - they are usually VERY brittle.

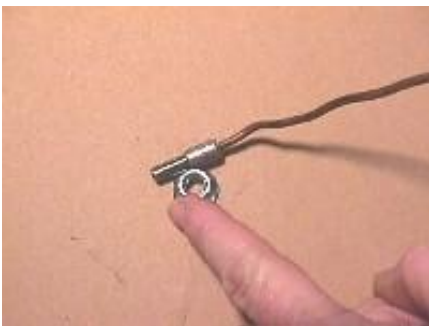
After the new valve is installed on the manifold, and the carb set back down on the manifold - you get to try to put the inside base nuts back on !! We use a bendable magnet to hold the nut on top of the stud, then rotate the nut onto the threads with either your finger, or a long screwdriver. There are other ways to do this, but we have found this to work best.

Be sure to hook up all the hoses to the valve and the air filter canister when you are putting everything back together.
