# 81-95 Short Shifter Installation

## 81-92 Images

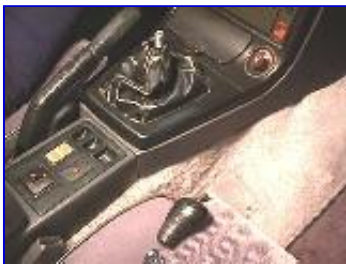
Start by removing the shift knob.

81-88's also have a chrome nut below the knob that needs to be removed.

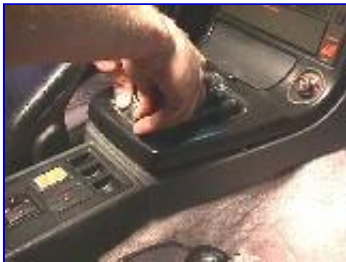
The panel is removed by just pulling up on the backside, or sides, as shown.

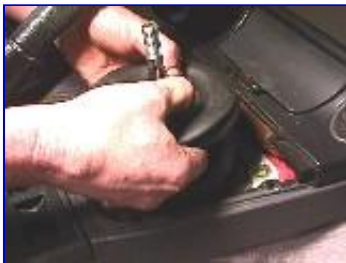
After the panel is pulled off, pull off the two round sealing boots by pulling them up over the shift lever.

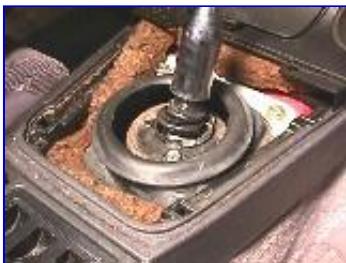
This is about what you will be looking at. On the 93-95, it is easiest if you remove the lower boot panel (as shown unbolted on the right) at this time.

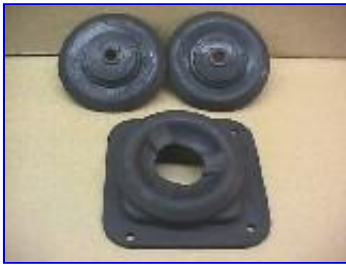
This is what a new "middle" boot "kit"

looks like --#64-490B-FB01 for 86-92,  
64-490A-FD01 for 93-95.

If you compare the center of the rectangular bottom boot, you can see how much the one in the customers' car has been cut away (86-92). We rarely have to replace the bottom part, but you have to buy the 3-piece "kit" to get the upper two round ones. (not our fault - talk to Mazda)

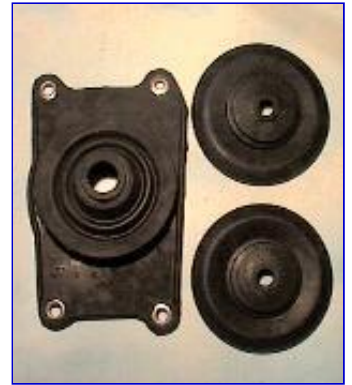
If you are lucky enough to have an uncut boot, just push the rubber down around the tower, as shown in the picture, so you can get to the three bolts.

(Does not apply to 93-95's)

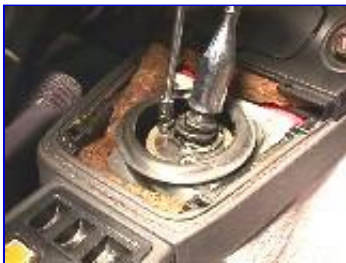
Remove the 3 bolts (10mm socket) that hold the round plate to the shift tower.

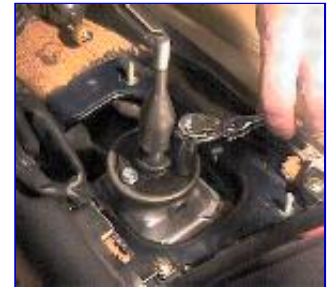
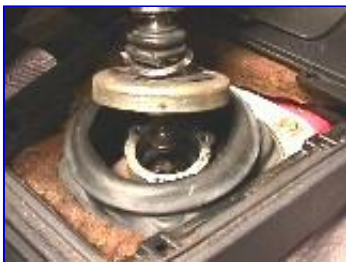
Pull the shift lever out of the shift tower.

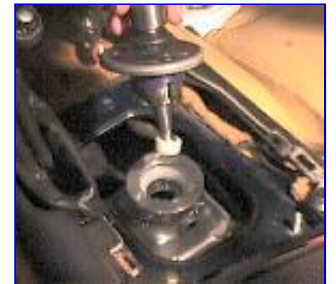
[This is a good time to watch the MPG movie we made of the installation. The steps are shown in the stills below, but it shows the actual time required of about 30 SECONDS. To view, click anywhere here, or on the picture to the left.](#)

Click on above image to view MPG (1.2meg, 27

seconds)

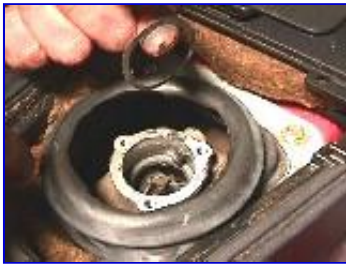
Fish out whatever is left of the shims and bushings -- we have found remnants of many bushings down there!

**NOTE:** Not removing the old bushing results in MOST of the problem calls we receive!!

**81-83**  
Transmissions do not have this lower nylon bushing - the radius for the shifter ball is machined into the tower.

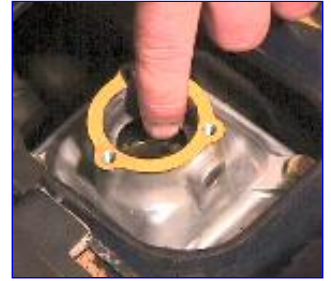
This is what it should look like AFTER old bushing AND spring have been removed.

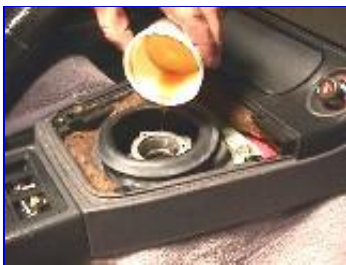
After cleaning the shifter hole, this is a good time to put the oil in the shift tower. We use 90W trans/diff oil. Fill to **ABOVE** the shift rod you can see down in the tower.

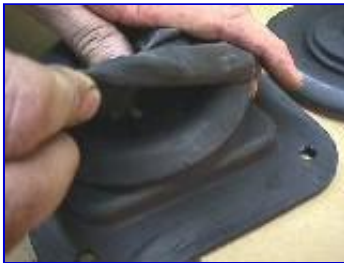
The middle boots slip down over the lever, and are pulled onto/around the lower boot. They are two sizes, so be sure to put the slightly smaller one on first.
